Manhole Inspection Summary

Manhole # S29S__006MH

Insp Date: **10/30/08 1:56 PM**

Location Address: **Ridgely St.**

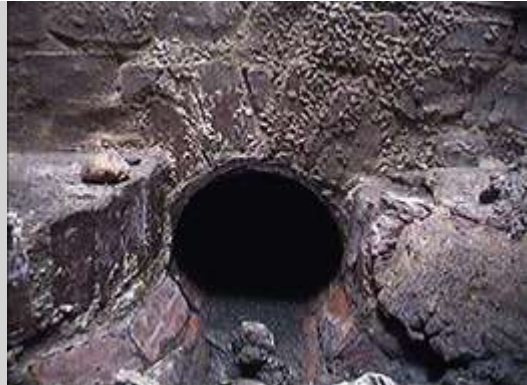
12 O'Clock Outflow

8 in. Circular Gravity Sewer
Pipe Out @ 12 O'Clock

Pipe Height: **8.4** (in.) Rod and Bar (Angled)
Pipe Material: **Clay** ☐ Pipe Lined
Invert Depth: **9.60** (ft.) Flow Characteristics: **None**
Deposits: ☒ None ☐ Mud ☐ Sludge ☐ Debris ☐ Grease
Silt Depth: **0** (in.) Deposits Extent:
Infiltration: **None** Pipe Seal Cond: **Sound**

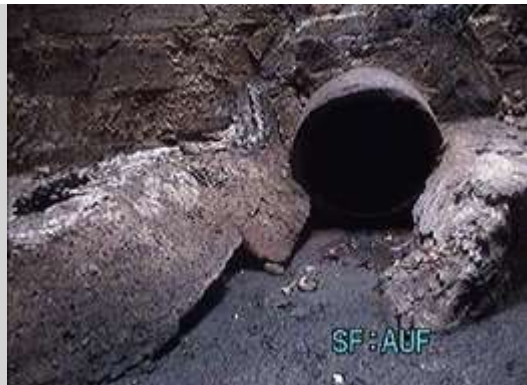
3 O'Clock Inflow

6 in. Circular Gravity Sewer
Pipe In @ 3 O'Clock

Pipe Height: **6** (in.) Rod and Bar (Angled)
Pipe Material: **Clay** ☐ Pipe Lined
Invert Depth: **9.09** (ft.) Flow Characteristics: **None**
Deposits: ☒ None ☐ Mud ☐ Sludge ☐ Debris ☐ Grease
Silt Depth: **0** (in.) Deposits Extent:
Infiltration: **None** Pipe Seal Cond: **Sound**
